<b>Make:</b>	Ford	<b>Model:</b>	Falcon	<b>Body Style:</b>	Wagon
<b>Year:</b>	2003	<b>Registration:</b>	LNA869	<b>Reg Expiry:</b>	28 Oct 2018
<b>WoF Expiry:</b>	16 Oct 2018	<b>Odometer:</b>	243,391 Kms	<b>Good No:</b>	18564465
<b>VIN:</b>	6FPAAAJGWA3S9327	<b>Next Service:</b>		<b>Service History:</b>	No

## Body Inspection Comments

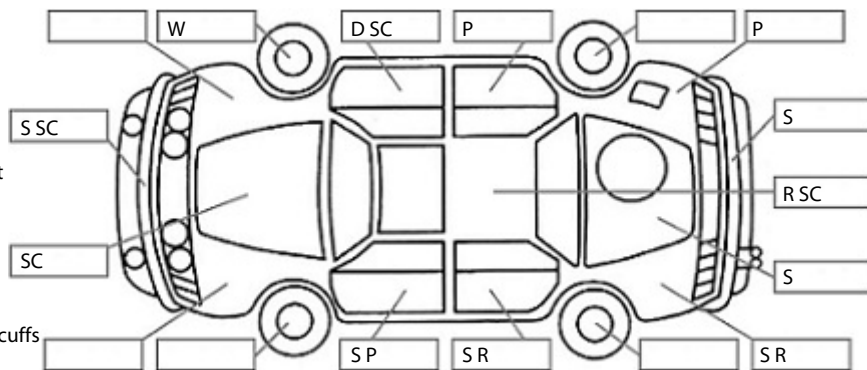
S = scratch  
D = dent  
R = rust  
PT = paint defect  
C = crack  
P = pin dent  
\* = decals  
SC = stone chips  
W = significant scuffs

Note: some defects & blemishes may not be displayed in the diagram

Rust on all door window frames. Rust LH dogleg. LH taillight has cracks. Rust in roof above RH cargo glass. Stonechips on windscreen and delaminating across top edge. Headlamps need buffing. Roof lining coming off, held with drawing pins. Both console lids are damaged.
