| Make: | Toyota | Model: | Hilux | Body Style: | Utility |
| Year: | 2011 | Registration: | FWN205 | Reg Expiry: | 27 Jan 2019 |

Body Inspection Comments

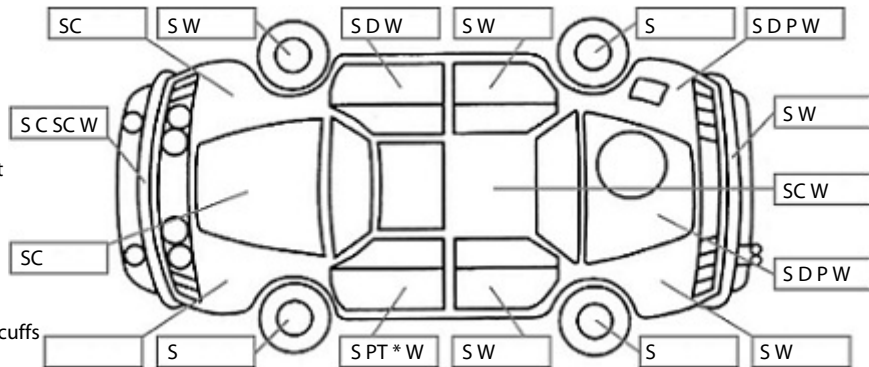
2 x screw holes on inside lip of left front guard, from where a aerial has been attached.

Crack in front bumper, by left bottom corner of grille.
