<b>Make:</b>	Mitsubishi	<b>Model:</b>	Pajero	<b>Body Style:</b>	SUV
<b>Year:</b>	2004	<b>Registration:</b>	BWS414	<b>Reg Expiry:</b>	04 Apr 2019
<b>WoF Expiry:</b>	16 Jul 2019	<b>Odometer:</b>	204,017 Kms	<b>Good No:</b>	18607420
<b>VIN:</b>	JMFLYV77W4J002439	<b>Next Service:</b>	?	<b>Service History:</b>	No

## Body Inspection Comments

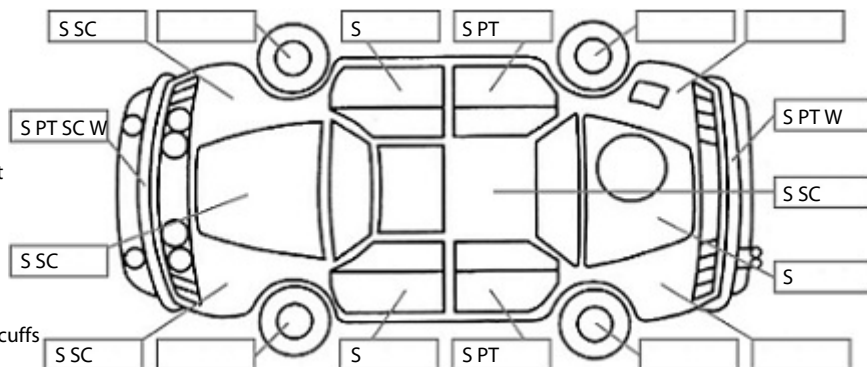
Paint flaking off front bumper, left side running board & large stone chips on front of bonnet. Radio aerial has been taped up. Stone chips in windscreen.
