| Make: | Mitsubishi | Model: | Pajero | Body Style: | SUV |
| Year: | 2004 | Registration: | CCE864 | Reg Expiry: | 12 Mar 2019 |

Body Inspection Comments

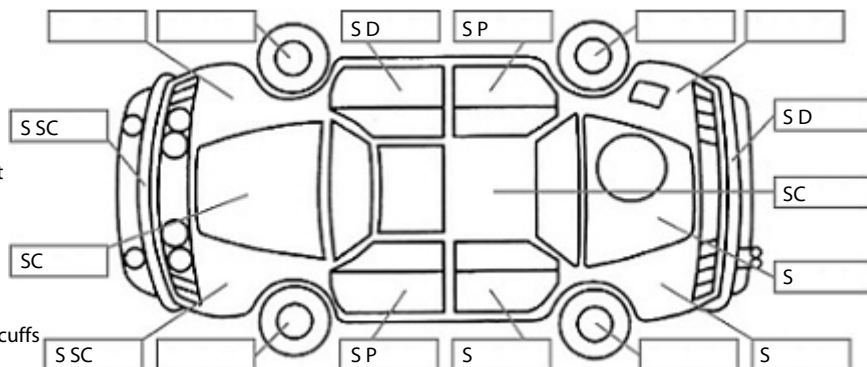
Rust in seam in roof beside sunroof, open sunroof. Stonechips on windscreen. LH taillight lens cracked. LH taillight not going. All outer door handles have paint coming off. Corrosion on both front wheels. Headlamps need buffing.
Wear on all seats. 4wd lights in dash have blown bulb.
