<b>Make:</b> Foton	<b>Model:</b> Tunland	<b>Body Style:</b> Utility
<b>Year:</b> 2013	<b>Registration:</b> LTF227	<b>Reg Expiry:</b> 24 Apr 2019
<b>WoF Expiry:</b> 15 Nov 2019	<b>Odometer:</b> 143,056 Kms	<b>Good No:</b> 19106956
<b>VIN:</b> LVAV2MBB4DJ027053	<b>Next Service:</b>	<b>Service History:</b> No

**Body Inspection Comments**

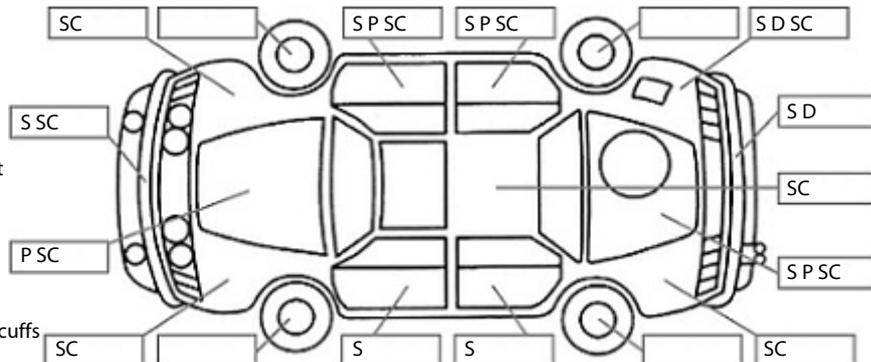
Aerial mounted on LF guard. Damage on rear bumper. Damage on tear of RR guard. Both rear mudflaps missing. Has jack, no tools. RH indicator repeater lamp in mirror is damaged. Stonechips on windscreen. Screw holes in dash and console. Damage on console lid. Wear on steering wheel. Wear on RF seat.
