Basic Vehicle Condition Guide

Make: Model: Honda Accord **Body Style:** Sedan Year: 2005 Registration: CLZ69 Reg Expiry: 19 Jul 2019 WoF Expiry: **Odometer:** 20 Sep 2019 286,501 Kms **Good No:** 19484231 VIN: JHMCL95305C203598 Next Service: 275500 **Service History:**

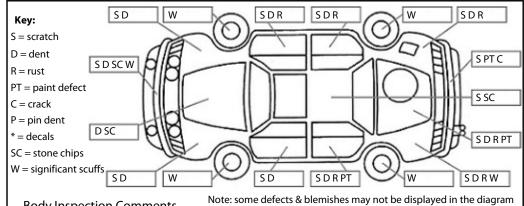
Body Inspection Comments

Front bumper loose Rear bumper trim loose Left rear 1/4 window smashed Front spoiler alignment right and left side Bonnet trim broken
