<b>Make:</b> Hyundai	<b>Model:</b> Tucson	<b>Body Style:</b> SUV
<b>Year:</b> 2005	<b>Registration:</b> CLE677	<b>Reg Expiry:</b> 19 Sep 2019
<b>WoF Expiry:</b> 19 Jun 2020	<b>Odometer:</b> 160,137 Kms	<b>Good No:</b> 19599299
<b>VIN:</b> KMHJN81BR5U09382	<b>Next Service:</b> 168000	<b>Service History:</b> No

**Body Inspection Comments**

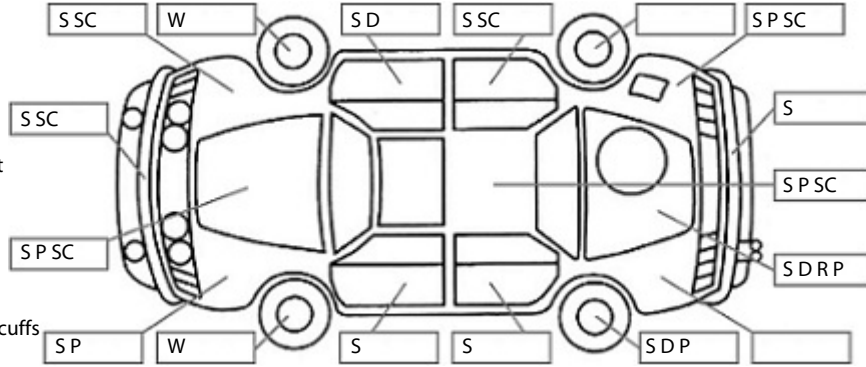
Note: some defects & blemishes may not be displayed in the diagram  
 Rear wiper not self parking. Headlamps need buffing. Dent in tailgate. Damage on RF door. LF grab handle in roof has tape on it. LH sunvisor mount loose. Interior light lens missing. Mirror switch not working properly. Heater vents not changing. AC not cold. All seats have wear/damage.
