<b>Make:</b> Nissan	<b>Model:</b> Vanette	<b>Body Style:</b> Van
<b>Year:</b> 2008	<b>Registration:</b> LYF832	<b>Reg Expiry:</b> 18 Jul 2019
<b>WoF Expiry:</b> 04 Feb 2020	<b>Odometer:</b> 157,010 Kms	<b>Good No:</b> 19784382
<b>VIN:</b> 7AT0DH19X18203508	<b>Next Service:</b>	<b>Service History:</b> No

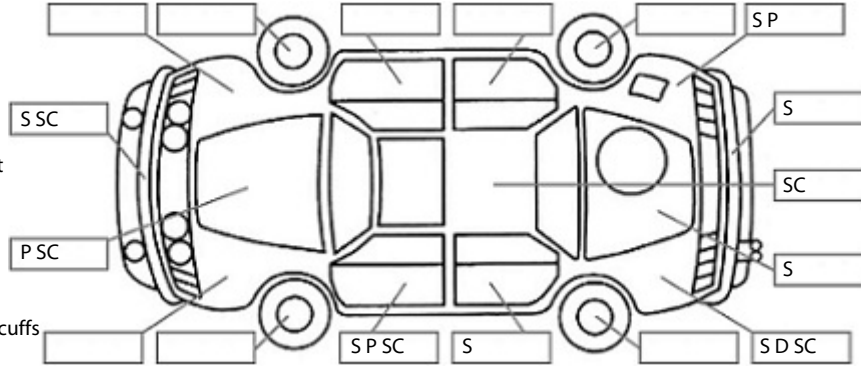
LF window not working. All rear windows painted out. LR guard has damage. LH D pillar has cracks in inside by threaded hole. Rust marks on inside of tailgate on seam at top. Rust marks under RF mirror mount. House paint splashes on vehicle. Paint splashes on seats, dash steering wheel, door cards.
