<b>Make:</b> Nissan	<b>Model:</b> Navara	<b>Body Style:</b> Utility
<b>Year:</b> 2007	<b>Registration:</b> DTA43	<b>Reg Expiry:</b> 11 Nov 2019
<b>WoF Expiry:</b> 19 Aug 2020	<b>Odometer:</b> 243,747 Kms	<b>Good No:</b> 19784471
<b>VIN:</b> VSKCVND40A0163461	<b>Next Service:</b> 253000	<b>Service History:</b> No

**Body Inspection Comments**

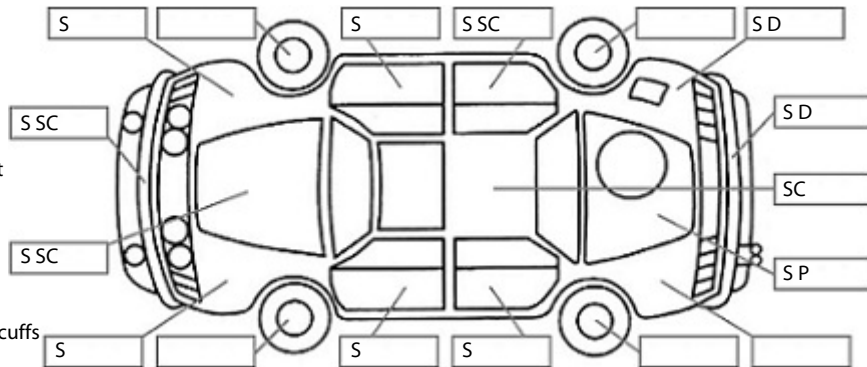
RR taillight broken and taped into vehicle, taillight bulb not going. LH number plate light damaged. Rear bumper step not secure. Tailgate handle trim damaged. Stonechips on windscreen. LR seat headrest missing. Wear on RF seat.
