<b>Make:</b>	GMC	<b>Model:</b>	Sierra	<b>Body Style:</b>	Utility
<b>Year:</b>	1995	<b>Registration:</b>	KFF443	<b>Reg Expiry:</b>	30 Jan 2020
<b>WoF Expiry:</b>	23 Mar 2020	<b>Odometer:</b>	155,809 Miles	<b>Good No:</b>	19803573
<b>VIN:</b>	2GTFK29S5S1531318	<b>Next Service:</b>		<b>Service History:</b>	No

## Body Inspection Comments

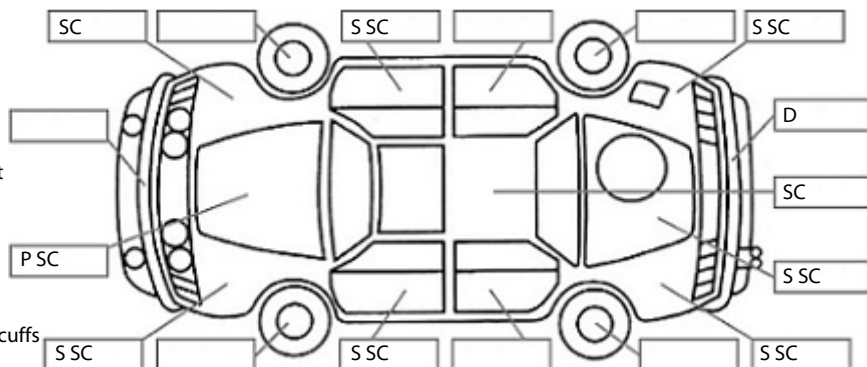
S = scratch  
D = dent  
R = rust  
PT = paint defect  
C = crack  
P = pin dent  
\* = decals  
SC = stone chips  
W = significant scuffs

Note: some defects & blemishes may not be displayed in the diagram

Rubber trim on both sides of vehicle has wear. LH mirror is damaged. LH taillight has crack in lens. Both taillight lenses need buffing. Stonechips on windscreen. LED lights on front bumper not going. Rubber insert on front bumper has wear. Radio has USA type tuner so will not get many NZ stations.
