<b>Make:</b>	Ford	<b>Model:</b>	Territory	<b>Body Style:</b>	Wagon
<b>Year:</b>	2007	<b>Registration:</b>	DYC774	<b>Reg Expiry:</b>	14 Feb 2020
<b>WoF Expiry:</b>	28 Aug 2020	<b>Odometer:</b>	232,799 Kms	<b>Good No:</b>	19804146
<b>VIN:</b>	6FPAAAJGAT7D69015	<b>Next Service:</b>		<b>Service History:</b>	No

## Body Inspection Comments

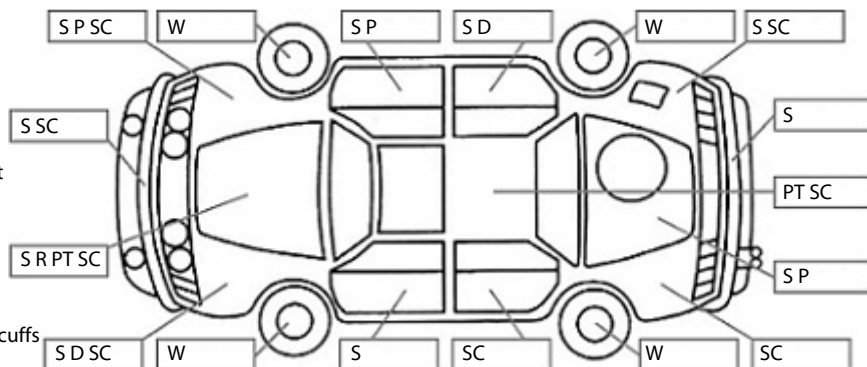
Moisture in RH taillight. Stonechips on windscreen. Rust on front of bonnet. Clearcoat is coming off vehicle. Wear on LF and RF inner door handles. Ignition switch has wear. Damage on console. Wire running across dash and under RHS. Cover over jack is damaged. Wear on back of 3rd row seats.
