<b>Make:</b>	Ford	<b>Model:</b>	Courier	<b>Body Style:</b>	Utility
<b>Year:</b>	2005	<b>Registration:</b>	CTY23	<b>Reg Expiry:</b>	06 May 2019
<b>WoF Expiry:</b>	29 Sep 2019	<b>Odometer:</b>	268,344 Kms	<b>Good No:</b>	19804325
<b>VIN:</b>	MNALSFD405W45232	<b>Next Service:</b>	276000	<b>Service History:</b>	No

## Body Inspection Comments

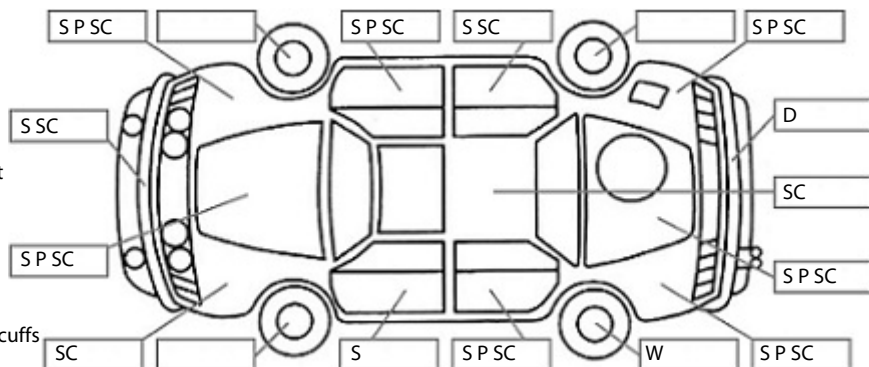
S = scratch  
D = dent  
R = rust  
PT = paint defect  
C = crack  
P = pin dent  
\* = decals  
SC = stone chips  
W = significant scuffs

Note: some defects & blemishes may not be displayed in the diagram

Crack in lens LH taillight. Canopy tailgate glass gas struts not working. Canopy has paint damage. No wheel brace. Stonechips on windscreen. Headlamps need buffing. Holes in roof both sides under tape, possibly from roof rack. Wear on RF seat.
