<b>Make:</b>	Mercedes-Benz	<b>Model:</b>	A190	<b>Body Style:</b>	Hatchback
<b>Year:</b>	1999	<b>Registration:</b>	DSD877	<b>Reg Expiry:</b>	07 Feb 2020
<b>WoF Expiry:</b>	23 Feb 2020	<b>Odometer:</b>	129,608 Kms	<b>Good No:</b>	19809519
<b>VIN:</b>	WDB1680332J232424	<b>Next Service:</b>	?	<b>Service History:</b>	No

## Body Inspection Comments

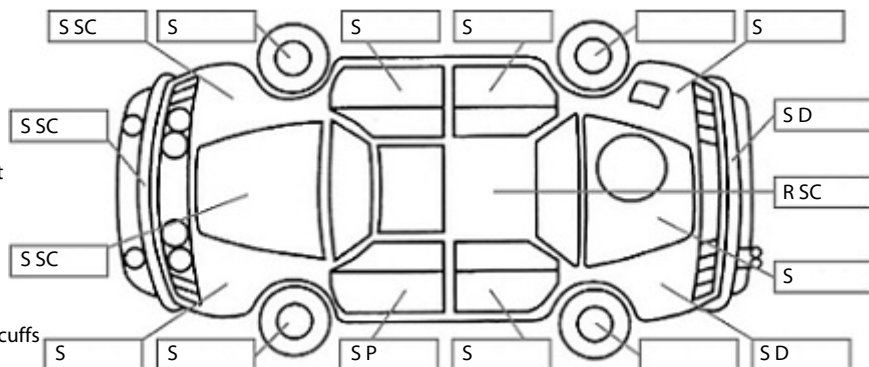
Plastic trim around high stop tail light is missing & rear tailgate gas struts need replaced. Stone chips in windscreen. Left rear tail light lens is cracked & broken. Right side wing mirror cover is a different colour to rest of vehicle.

Note: some defects & blemishes may not be displayed in the diagram
