| Make: | Honda | Model: | CRV | Body Style: | SUV |
| Year: | 2005 | Registration: | GMH4 | Reg Expiry: | 09 May 2020 |

Body Inspection Comments

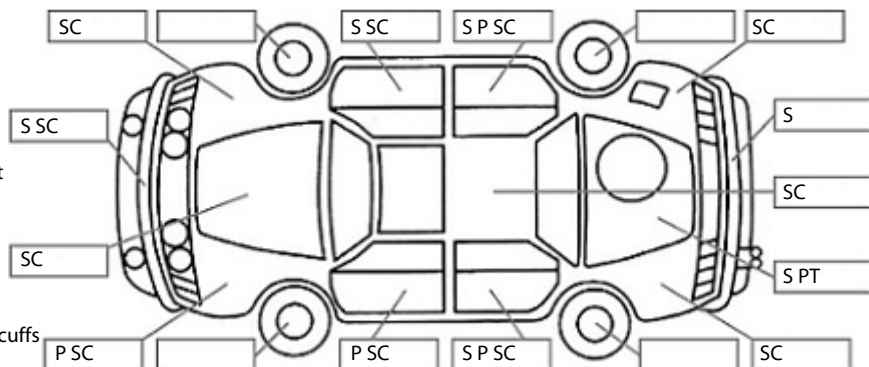
Clearcoat coming off spare wheel cover. Stonechips on windscreen.
Crack in lens over speedo. Wear on RF seat and steering wheel.
