Report ID:	24,876,755	Version:	2
Created:	23 Apr 2026

Make:	Toyota	Model:	Hiace
Body Style:	Van	Year:	2006
Rego No.:	KYG339	Rego Expiry:	06 Aug 2026
WoF Expiry:	25 Feb 2027	Odometer:	151,626 Kms
Good No.:	24876755	VIN:	7AT0H60FX13035863
Next Service:	133,836kms	Service History:	No

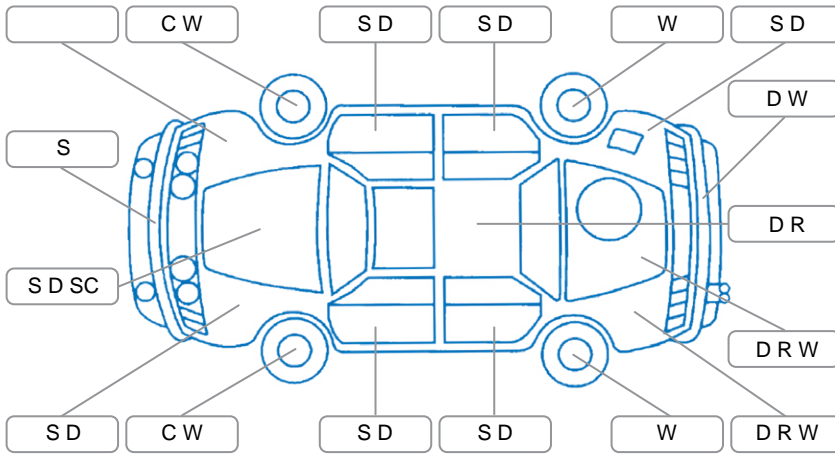
Note: some defects and blemishes may not be displayed in the diagram

Tow point cover in front bumper is missing. Left corner mirror is missing. Left sliding door rear side lock is faulty. (Can not close door properly). Rear emblem is missing. Rear bumper is not fitted correctly. Left tail light is cracked. Numbers of dents on roof. Inside wear of spare tyre.
