Report ID:	24,876,764	Version:	2
Created:	21 Apr 2026

Make:	Toyota	Model:	Hiace
Body Style:	Van	Year:	2014
Rego No.:	MDP792	Rego Expiry:	23 Nov 2026
WoF Expiry:	14 Aug 2026	Odometer:	169,649 Kms
Good No.:	24876764	VIN:	7AT0H60FX19204520
Next Service:	165,200kms	Service History:	No

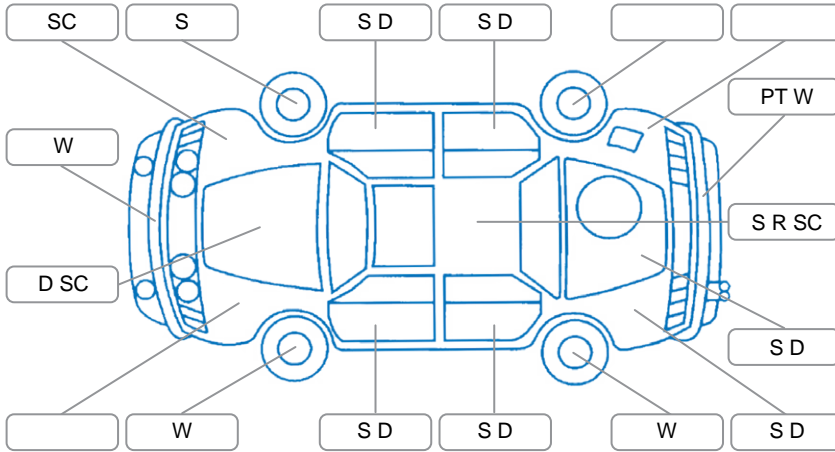
Front tow pint cap is missing. Major stone crack in bottom centre black area of windshield. Out side edge wear of left front tyre. Left sill lip has minor bent. Dents and scuff around cargo area. Right tail light is cracked.
