Report ID:	24,877,662	Version:	2
Created:	27 May 2026

Make:	Mitsubishi	Model:	Triton
Body Style:	Utility	Year:	2021
Rego No.:	NHN227	Rego Expiry:	30 Nov 2026
WoF Expiry:	04 Mar 2027	Odometer:	220,775 Kms
Good No.:	24877662	VIN:	MMAJLKK10MH003338
Next Service:	no record	Service History:	No

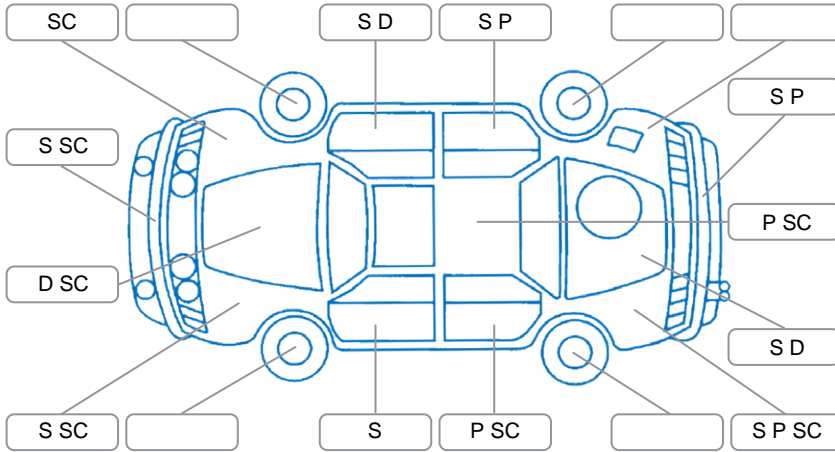
Note: some defects and blemishes may not be displayed in the diagram

Right door mirror cover has minor dent. Paint is cracked around dent in tailgate and around pin dent in right rear door. Edge of both tail lights are cracked. Minor stone cracks in windshield. Minor bents on left cant rail. Screw holes inside of right front guard.
