# **Basic Condition Guide**

•	Report ID:	24,913,169	Version:	2
	Created:	26 Nov 2025

Make:	LDV	Model:	G10
Body Style:	Van	Year:	2021
Rego No.:	NUR746	Rego Expiry:	15 Nov 2025
WoF Expiry:	06 Nov 2025	Odometer:	38,588 Kms
Good No.:			LSKG4GL18MA123880
Next Service:			Yes
Note: This report is	•		
			arts have not been dismantled or h from cold. The Vendor recommend:

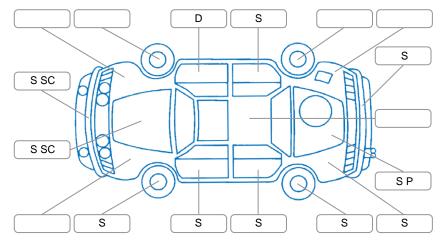
W = Significant scuffs S = ScratchR = RustC = Crack\* = DecalsD = DentPT = Paint defect P = Pin dentSC = Stone Chips

Note: some defects and blemishes may not be displayed in the diagram  $\,$

Front passenger tyre worn down to wire.

Minor stone chip in windscreen.
