Basic Condition Guide

•	Report ID:	24,984,577	Version:	1
	Created:	11 Nov 2025

Make:	Suzuki	Model:	Grand Vitara
Body Style:	SUV	Year:	2005
Rego No.:	CUW873	Rego Expiry:	10 Aug 2026
WoF Expiry:	31 Oct 2026	Odometer:	151,113 Kms
Good No.:	24984577	VIN:	JSAFTD62V00250844
Next Service:	31/10/26 or 161105km	Service History:	No

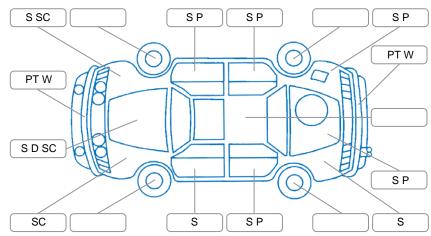
Note: some defects and blemishes may not be displayed in the diagram $\,$

Stone chips in windscreen.

Left rear bumper trim loose.

Paint flaking off majority of rear bumper.
