# **Basic Condition Guide**

Report ID: 24,985,149		Version:	2
Created:	02 Dec 2025

Make:	Skoda	Model:	Superb
Body Style:	Wagon	Year:	2022
Rego No.:	PKP422	Rego Expiry:	03 Aug 2026
WoF Expiry:	21 Aug 2026	Odometer:	205,559 Kms
Good No.:	24985149	VIN:	TMBKD9NP7N7041618
Next Service:	17/6/26 or 207000km	Service History:	No

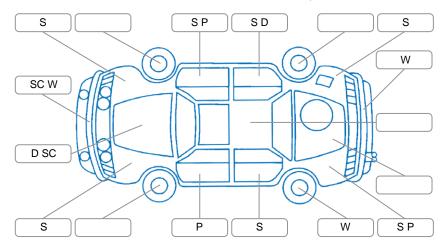
Note: some defects and blemishes may not be displayed in the diagram

Part of bottom front bumper missing on RH side.

Holes in rear bumper.

Both front wheels and RH rear wheel missing centre caps.

Stone chips in windscreen.
