Basic Condition Guide

•	Report ID:	25,004,276	Version:	1
	Created:	18 Nov 2025

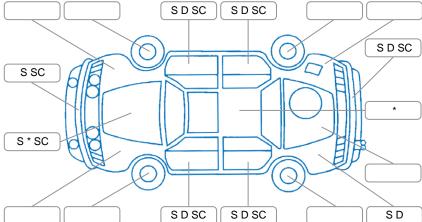
W = Signific D = DentPT = Paint defect P = Pin dentSC = Stone Chips

Note: some defects and blemishes may not be displayed in the diagram $\,$

Body Inspection Comments

Front tires balding inner edges.

Front bumper poor fit.

Rear spoiler coming off
