# **Basic Condition Guide**

| Make: | Toyota | Model: | Hilux |
| Body Style: | Utility | Year: | 2014 |
| Good No.: | 25960032 | VIN: | MR0FZ22G801087549 |

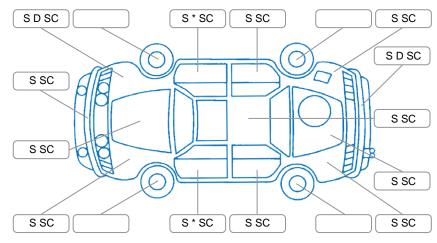
| , | | | | |
|---|---|---|---|---|
| S = Scratch | R = Rust | C = Crack | * = Decals | W = Significant scuffs |
| D = Dent | PT = Paint defect | P = Pin dent | SC = Stone Chips | |

Note: some defects and blemishes may not be displayed in the diagram

Glue from gps mount on windscreen/
