# **Basic Condition Guide**

•	Report ID:	25,962,443	Version:	2
	Created:	18 Dec 2025

Make:	Toyota	Model:	Hilux		
Body Style:	Utility	Year:	2015		
Rego No.:	JLC35	Rego Expiry:	15 Jan 2026		
WoF Expiry:	14 Jan 2026	Odometer:	207,719 Kms		
Good No.:	25962443	VIN:	MR0HZ22G203520022		
Next Service:	219,500 Kms	Service History:	No		
Note: This report is not a warranty					
This report is a guide only. Consideration is made for age and mileage. Parts have not been dismantled or diagnostic testing undertaken. The vehicle has been driven up to 50km/h from cold. The Vendor recommends a full mechanical inspection prior to purchase and this can be arranged for an additional charge.

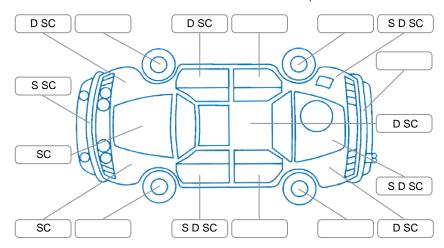
Note: some defects and blemishes may not be displayed in the diagram

Both running boards are dented. Both front sill step plates are worn. RH taillight cracked and has moisture inside. Canopy window tints are scratched. RH canopy side window struts weak.
