Basic Condition Guide

Make:	Mitsubishi	Model:	Triton			
Body Style:	Utility	Year:	2021			
Rego No.:	NHZ8	Rego Expiry:	09 Feb 2026			
WoF Expiry:	14 Mar 2026	Odometer:	276,336 Kms			
Good No.:	26049859	VIN:	MMAJLKL10MH004720			
Next Service:	276,280km's	Service History:	Yes			
Note: This report is not a warranty						
This report is a guide only. Consideration is made for age and mileage. Parts have not been dismantled or diagnostic testing undertaken. The vehicle has been driven up to 50km/h from cold. The Vendor recommends a

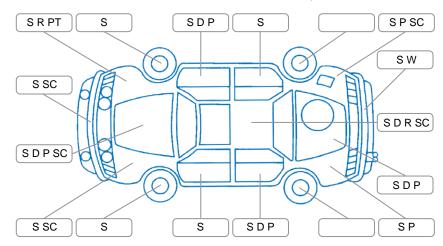
Key				
S = Scratch	R = Rust	C = Crack	* = Decals	W = Significant scuffs
D = Dent	PT = Paint defect	P = Pin dent	SC = Stone Chips

Note: some defects and blemishes may not be displayed in the diagram

Both right & left side running boards are dented & have cracks in end caps. Both rear taillight lenses are cracked & broken. Small stone crack in left side of windscreen.
