Report ID:	26,050,197	Version:	1
Created:	17 Dec 2025

Make:	Toyota	Model:	Hilux
Body Style:	Utility	Year:	2005
Rego No.:	DAR866	Rego Expiry:	24 Aug 2026
WoF Expiry:	11 Jun 2026	Odometer:	431,346 Kms
Good No.:	26050197	VIN:	MR0CZ12G000003839
Next Service:	No records	Service History:	No

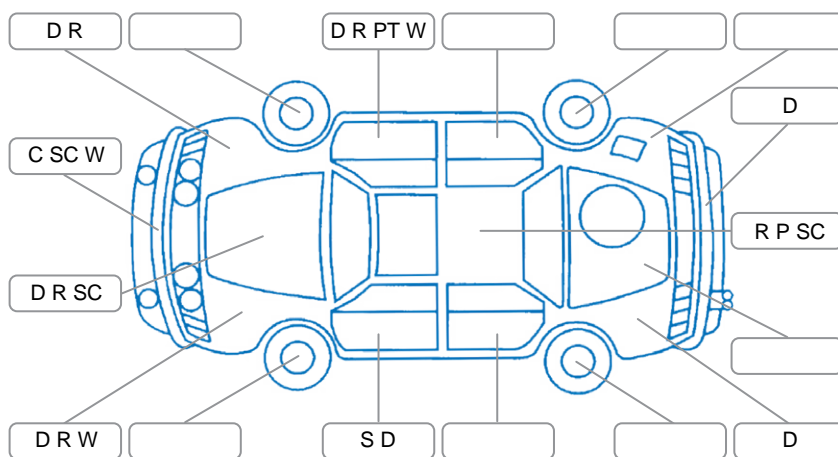
Note: some defects and blemishes may not be displayed in the diagram

Screw holes inside of left front guard. Both side edges of front bumper are not fitted correctly. GPS aerial on roof. Rear mad flaps are bent. Surface rust is developing on deck steel. Both sill paint worn. Paint cracked on right cab corner and right door. Minor dent on left cab corner.
