Make:	Toyota	Model:	Fortuner
Body Style:	SUV	Year:	2022
Rego No.:	PAK144	Rego Expiry:	07 Feb 2026
WoF Expiry:	29 Jan 2027	Odometer:	178,349 Kms
Good No.:	26050454	VIN:	MR0BA3FS401125224
Next Service:	180,000kms	Service History:	No

**Body Inspection Comments**

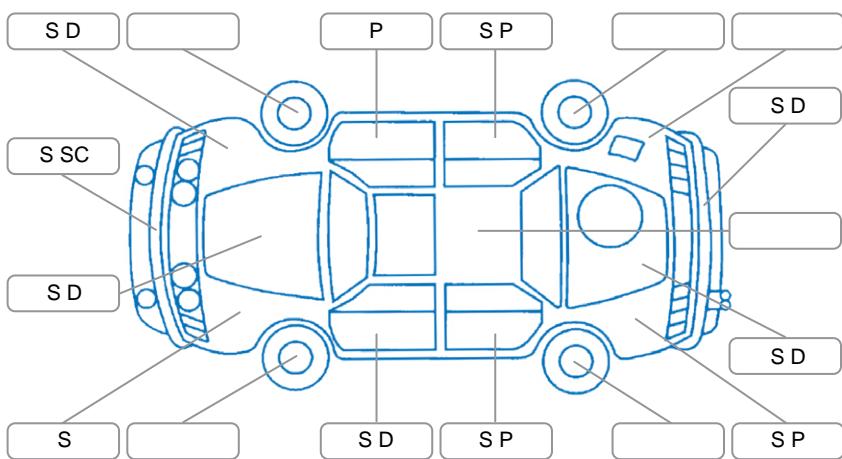
Both rear inner wheel arch has minor dents. Right sill paint is worn. Numbers of pin dents on right front and rear doors. Right front door seal rubber is torn. Small stone cracks in left side of windshield. Left tail light is cracked. Front grille is cracked. Left license light is not operating.
