| Make: | Mitsubishi | Model: | Triton |
| Body Style: | Utility | Year: | 2017 |
| Good No.: | 26050533 | VIN: | MMAJYKL10HH012969 |

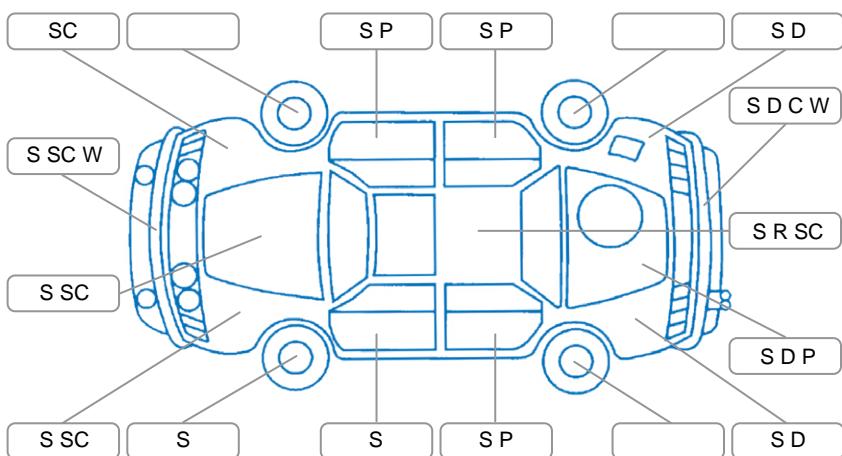
Note: some defects and blemishes may not be displayed in the diagram

Two small stone cracks in windscreen. Surface rust along top edge of windscreen. Large cracks, hole & scratches/scuff on left rear bumper cover. Dents in left & right rear corner panels of ute cab.
