Report ID:	26,050,726	Version:	3
Created:	02 Feb 2026

Make:	Mitsubishi	Model:	Triton
Body Style:	Utility	Year:	2019
Rego No.:	LYA447	Rego Expiry:	28 Apr 2026
WoF Expiry:	22 Jan 2026	Odometer:	198,905 Kms
Good No.:	26050726	VIN:	MMAJYKK10JH027815
Next Service:	206,000km's	Service History:	Yes

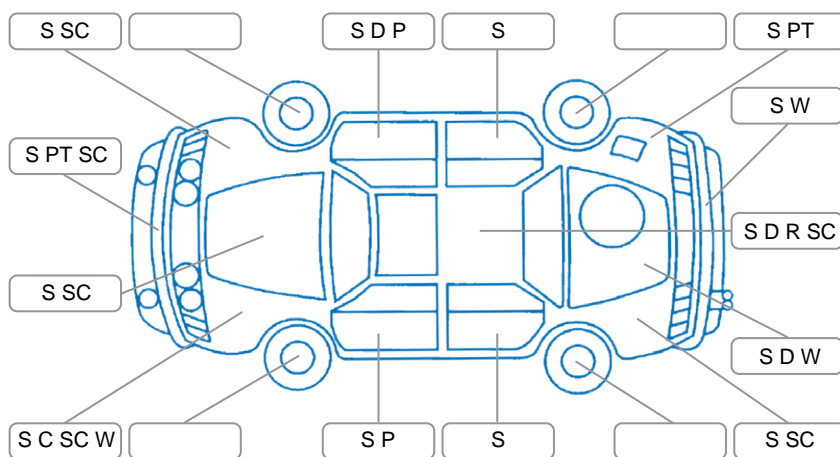
Note: some defects and blemishes may not be displayed in the diagram

Large crack in left side of windscreen. Tonneau support bar bracket needs refitted on left side & front tonneau cover mounting studs need refitted. Left side wing mirror surround & housing is cracked and broken. Both rear tyres need replaced. Crack in bottom of left front guard flare
