| Report ID: | 26,054,297 | Version: | 1 |

| Make: | Holden | Model: | Commodore |
| Body Style: | Wagon | Year: | 2020 |

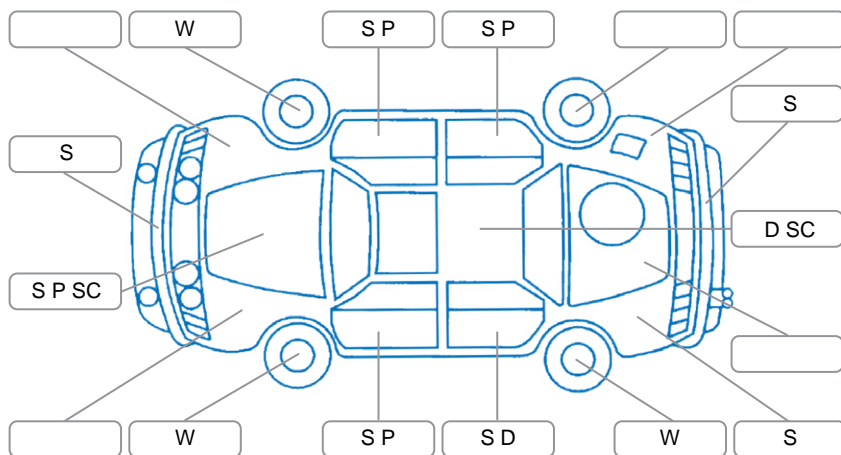
Note: some defects and blemishes may not be displayed in the diagram

FR and FL door interior seal torn
L cant rail dent
After market holes in roof, front bumper, rear bumper
