Report ID:	26,055,443	Version:	8
Created:	18 Feb 2026

Make:	Volkswagen	Model:	Crafter
Body Style:	Van	Year:	2020
Rego No.:	NEA573	Rego Expiry:	23 Nov 2026
WoF Expiry:		Odometer:	58,817 Kms
Good No.:	26055443	VIN:	WV1ZZZSYZM9004211
Next Service:	76000	Service History:	Yes

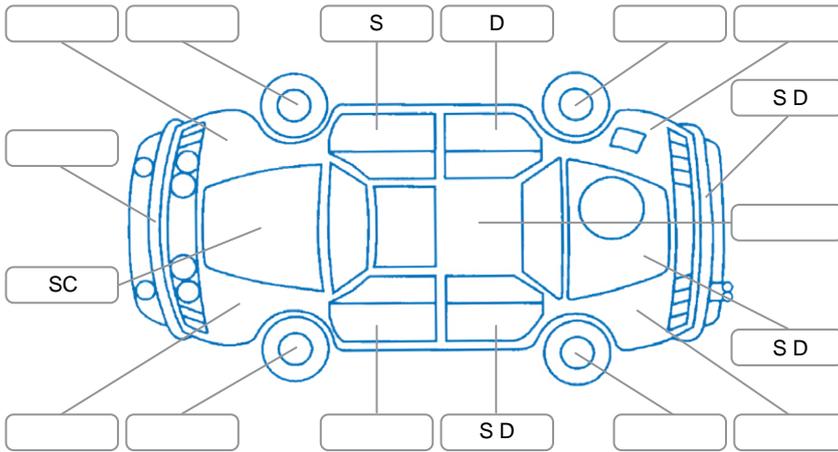
S = Scratch R = Rust C = Crack * = Decals W = Significant scuffs
 D = Dent PT = Paint defect P = Pin dent SC = Stone Chips

Note: some defects and blemishes may not be displayed in the diagram

Left van side molding not secure. Hood lining refit.
