Basic Condition Guide

•	Report ID:	26,068,475	Version:	1
	Created:	09 Nov 2025

Make:	Toyota	Model:	Vitz
Body Style:	Hatchback	Year:	2004
Rego No.:	GGP262	Rego Expiry:	07 Apr 2026
WoF Expiry:	26 May 2026	Odometer:	211,365 Kms
Good No.:	26068475	VIN:	7AT0H63EX11077646
Next Service:	217,000 Kms	Service History:	No

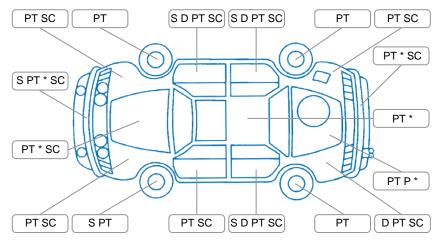
•				
S = Scratch	R = Rust	C = Crack	* = Decals	W = Significant scuffs
D = Dent	PT = Paint defect	P = Pin dent	SC = Stone Chips

Note: some defects and blemishes may not be displayed in the diagram

Front bumper fits poorly.

Paint condition is poor all over.
