# **Basic Condition Guide**

Make:	Hyundai	Model:	lload
Body Style:	Van	Year:	2016
Rego No.:	KBN275	Rego Expiry:	19 Dec 2025
WoF Expiry:	11 Sep 2026	Odometer:	161,843 Kms
Good No.:	26068554	VIN:	KMFWBX7KLGU824034
Next Service:	172,000 Kms	Service History:	Yes

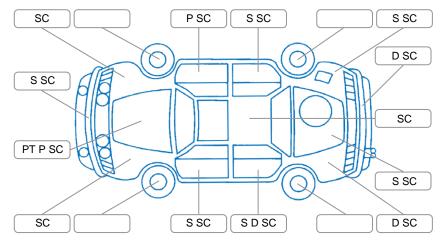
rey				
S = Scratch	R = Rust	C = Crack	* = Decals	W = Significant scuffs
D = Dent	PT = Paint defect	P = Pin dent	SC = Stone Chips

Note: some defects and blemishes may not be displayed in the diagram

Tailgate seal damaged. Rear window scratched.

Windscreen molding missing.
