•	Report ID:	26,069,142	Version:	2
	Created:	05 Dec 2025

Make:	Holden	Model:	Commodore
Body Style:	Wagon	Year:	2020
Rego No.:	MWN670	Rego Expiry:	15 Jun 2026
WoF Expiry:	16 Jun 2026	Odometer:	187,476 Kms
Good No.:	26069142	VIN:	W0VZM8ECXL1020421
Next Service:	195,000 Kms	Service History:	No

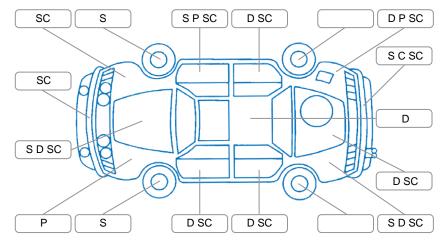
rey				
S = Scratch	R = Rust	C = Crack	* = Decals	W = Significant scuffs
D = Dent	PT = Paint defect	P = Pin dent	SC = Stone Chips

Note: some defects and blemishes may not be displayed in the diagram

Holes drilled in front and rear bumpers. Additional aerial port and cut electrical harness on roof. Drivers door seal torn.

LF door bent at bottom of door. Minor dent in LH sill.

LH cant rail dented.
