## **Basic Condition Guide**

•	Report ID:	26,069,157	Version:	1	
	Created:	03 Dec 2025

Holden	Model:	Commodore
Wagon	Year:	2020
MQD230	Rego Expiry:	09 Jan 2026
13 Nov 2026	Odometer:	270,333 Kms
26069157	VIN:	W0VZM8EC6K1073132
285,000 Kms	Service History:	No
	Wagon MQD230 13 Nov 2026 26069157	Wagon         Year:           MQD230         Rego Expiry:           13 Nov 2026         Odometer:           26069157         VIN:

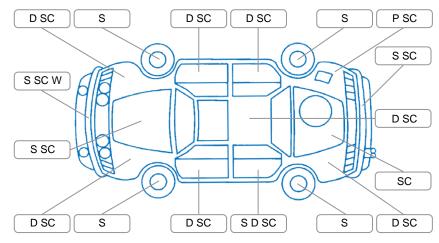
Note: some defects and blemishes may not be displayed in the diagram

Holes drilled in front and rear bumpers. 4 additional aerial ports and cut electrical

harness on roof. Spare wheel needs secured. Drivers door check strap clicking. Drivers door seal torn.

Moisture in RH taillight. Both sills dented.
