| Report ID: | 26,069,161 | Version: | 1 |

| Make: | Mazda | Model: | Bt-50 |
| Body Style: | Utility | Year: | 2018 |

Body Inspection Comments

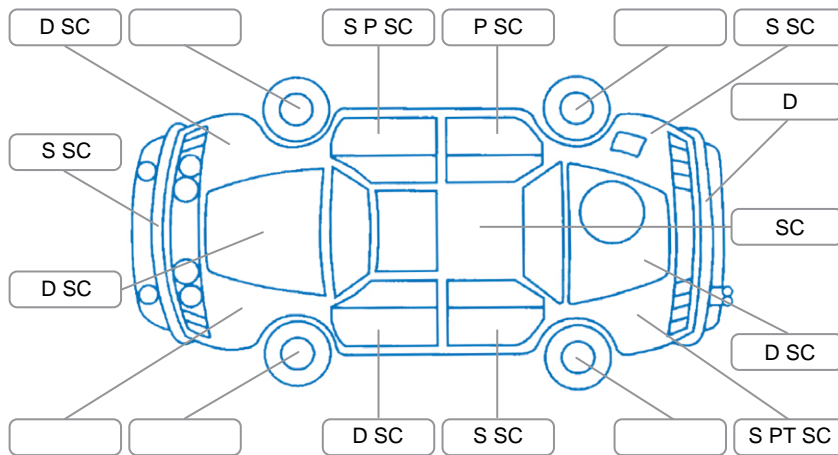
Note: some defects and blemishes may not be displayed in the diagram

LH mirror assembly cracked. RF/LF/LR step plates worn.
All door seals torn. RH sill worn.
Front bumper/RF guard lining held by cable ties.
Both LH taillights cracked.
