| Make: | Nissan | Model: | Fuga |
| Body Style: | Sedan | Year: | 2006 |

Note: This report is not a warranty

Body Inspection Comments

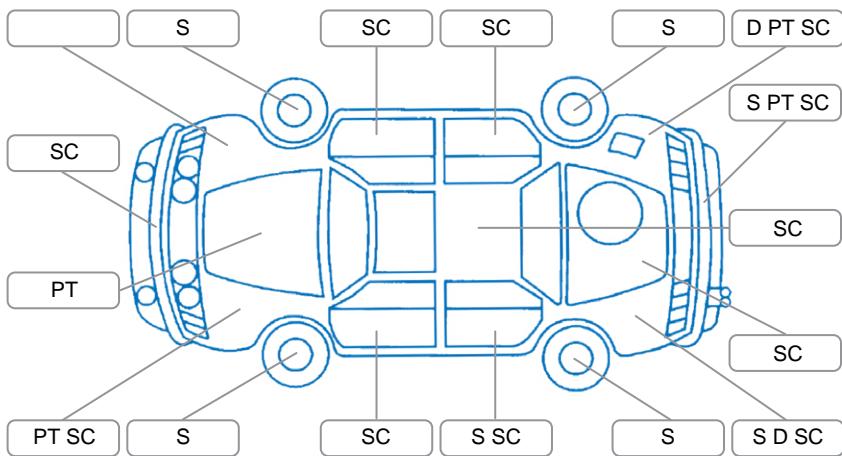
S = Scratch R = Rust C = Crack * = Decals W = Significant scuffs
 D = Dent PT = Paint defect P = Pin dent SC = Stone Chips

Note: some defects and blemishes may not be displayed in the diagram
