Report ID:	26,069,306	Version:	1
Created:	07 Dec 2025

Make:	Mercedes-Benz	Model:	C200
Body Style:	Sedan	Year:	2011
Rego No.:	PBZ981	Rego Expiry:	02 Feb 2026
WoF Expiry:	30 Oct 2025	Odometer:	161,013 Kms
Good No.:	26069306	VIN:	WDD2040482A589433
Next Service:	123,700 Kms	Service History:	No

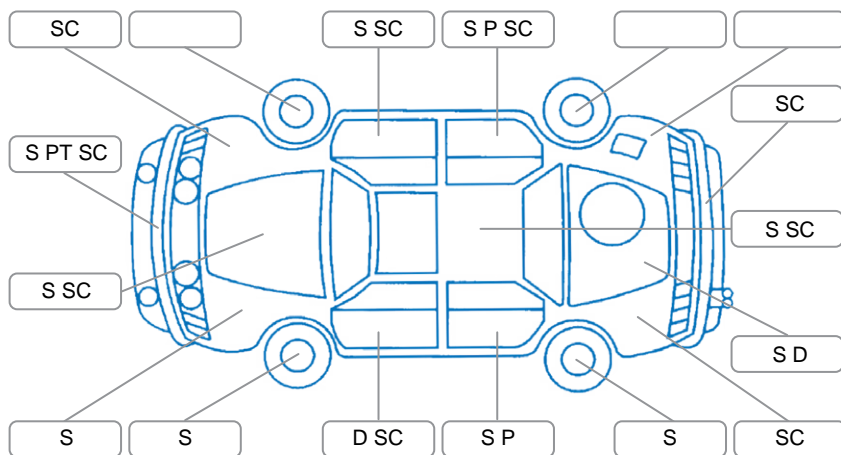
S = Scratch R = Rust C = Crack \* = Decals W = Significant scuffs  
D = Dent PT = Paint defect P = Pin dent SC = Stone Chips

Note: some defects and blemishes may not be displayed in the diagram
