Basic Condition Guide

| • | Report ID: | 26,082,021 | Version: | 1 |

| Mitsubishi | Model: | Triton |
| Utility | Year: | 2020 |

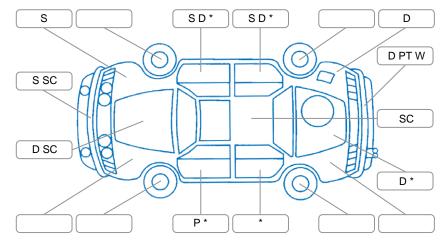
Note: some defects and blemishes may not be displayed in the diagram

Body Inspection Comments

Stone chip in front windscreen
