Report ID:	26,127,163	Version:	1
Created:	13 Feb 2026

Make:	Mazda	Model:	Bt-50
Body Style:	Utility	Year:	2013
Rego No.:	GRA258	Rego Expiry:	01 Feb 2026
WoF Expiry:	02 Aug 2026	Odometer:	241,018 Kms
Good No.:	26127163	VIN:	MMOUP0YF100148417
Next Service:	242,000 Kms	Service History:	Yes

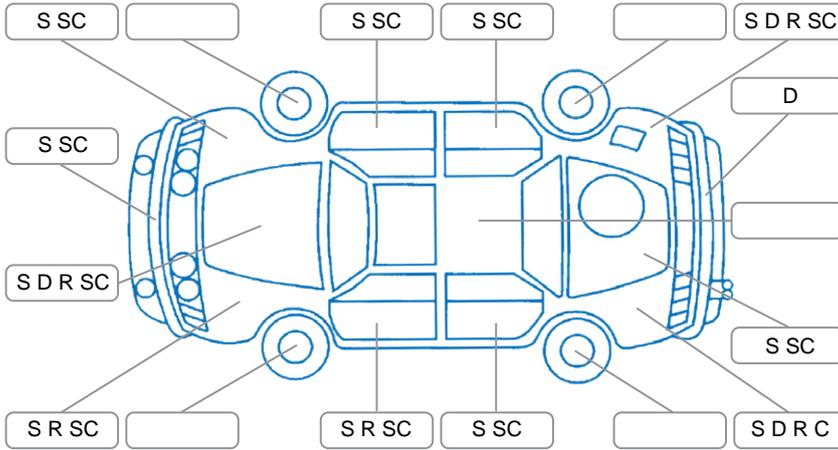
Note: some defects and blemishes may not be displayed in the diagram

Poor paint work clear coat coming off and faded. Dent lhs C pillar. Rear bumper hit rear bodywork due to large dent/impact and now has poor fit. Vehicle has been lifted. Driver side door handle gets stuck when opening
