Report ID:	26,128,286	Version:	3
Created:	08 Apr 2026

Make:	Honda	Model:	Vezel
Body Style:	Wagon	Year:	2014
Rego No.:	NRL40	Rego Expiry:	10 Aug 2023
WoF Expiry:	17 Nov 2024	Odometer:	201,119 Kms
Good No.:	26128286	VIN:	7AT08GDHX21037445
Next Service:	overdue	Service History:	Yes

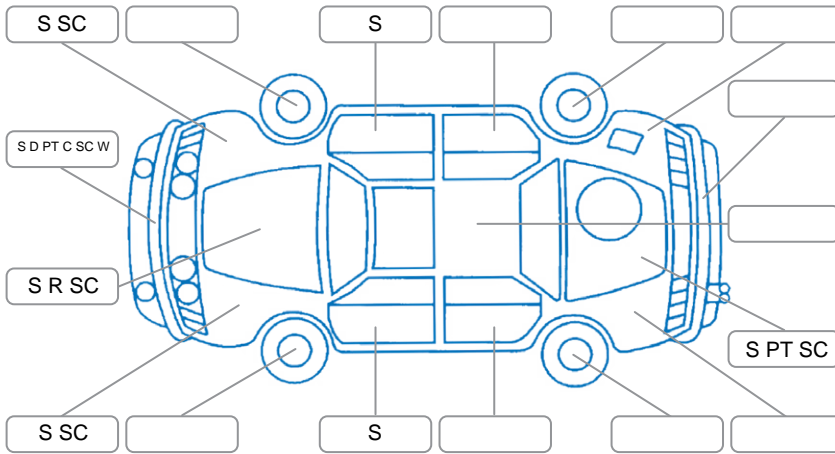
Both front tires bald on inner edge and RHF on outer also.  
 Front bumper damaged badly.  
 Stone chips scratched scuffed dents all over
