| Report ID: | 26,128,446 | Version: | 1 |

| Make: | Skoda | Model: | Superb |
| Body Style: | Wagon | Year: | 2023 |

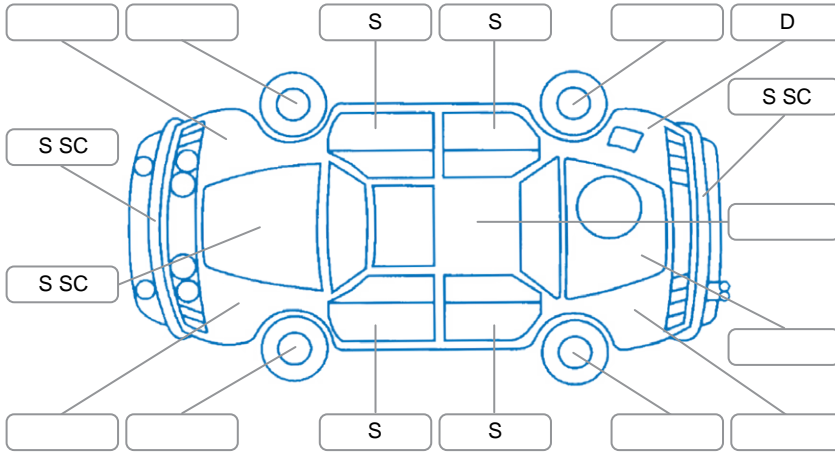
Note: some defects and blemishes may not be displayed in the diagram

Front bumper cracked.
 Holes in bumpers and roof for previous police equipment
