| Report ID: | 27,092,650 | Version: | 4 |

| Make: | Nissan | Model: | Navara |
| Body Style: | Utility | Year: | 2021 |

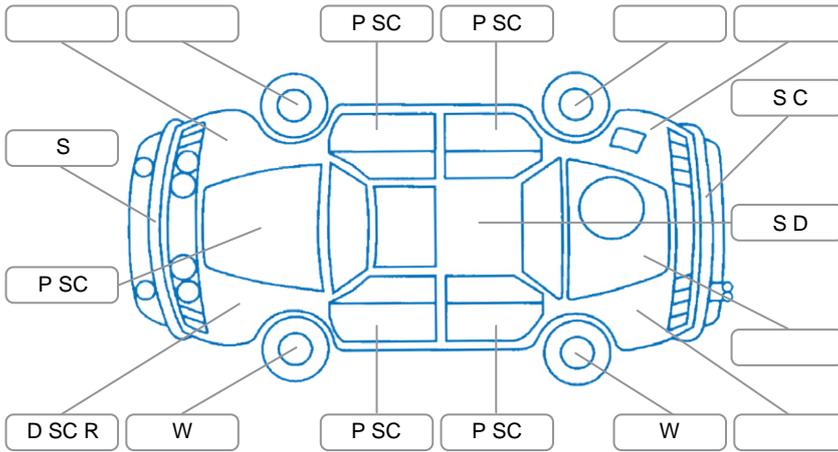
S = Scratch R = Rust C = Crack * = Decals W = Significant scuffs
 D = Dent PT = Paint defect P = Pin dent SC = Stone Chips

Note: some defects and blemishes may not be displayed in the diagram

RFD seal torn. RF and RR seat base torn. RF seat centre adjuster trim missing. L running board cracked. Roof aerial damaged. Steering wheel buttons worn. RF carpet worn. Right B pillar gouged and dents. Roof rack key missing. LR tyre sidewall damage. FB moulding cracked.
