Basic Condition Guide

| • | Report ID: | 27,105,952 | Version: | 2 |

| Make: | Mitsubishi | Model: | Pajero |
| Body Style: | SUV | Year: | 2005 |

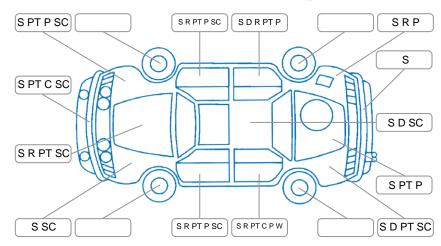
Note: some defects and blemishes may not be displayed in the diagram

Right Taillight Cracked, Fog Lights Missing

Sunroof Opening & Frame All Door Sills & Doors Surface Rust

Headlights Faded & Minor Stone Chips Windscreen - Expected for Age & Mileage
