| Report ID: | 27,117,604 | Version: | 1 |

| Make: | Toyota | Model: | Hiace |
| Body Style: | Van | Year: | 2015 |

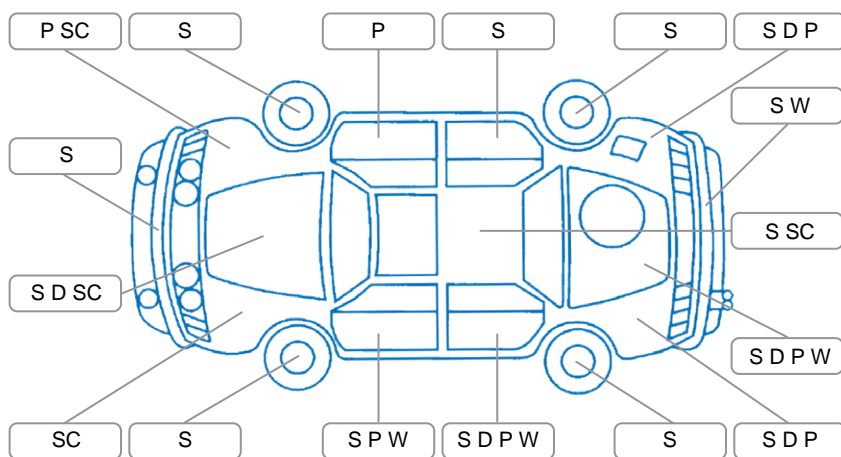
Note: some defects and blemishes may not be displayed in the diagram

Two small stone cracks in left side of windscreen.
