# **Basic Condition Guide**

•	Report ID:	27,151,470	Version:	1
	Created:	08 Nov 2025

Make:	KIA	Model:	Sportage
Body Style:	suv	Year:	2018
Rego No.:	QAR460	Rego Expiry:	08 May 2026
WoF Expiry:	08 Aug 2026	Odometer:	199,072 Kms
Good No.:	27151470	VIN:	KNAPN81CSJ7458340
Next Service:	209,000 km	Service History:	No

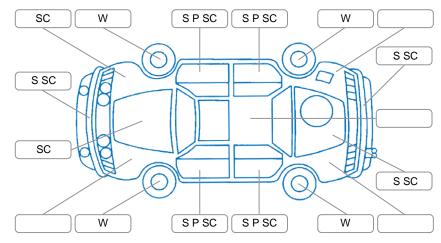
Note: some defects and blemishes may not be displayed in the diagram

Slight surface rust spot on L/F corner of top of windscreen. Minor pitting in windscreen.
