Basic Condition Guide

Report ID:	27,157,981	Version:	1
Created:	06 Nov 2025

Make:	Ford	Model:	Ecosport
Body Style:	SUV	Year:	2016
Rego No.:	KFA863	Rego Expiry:	18 Mar 2026
WoF Expiry:	20 Nov 2026	Odometer:	78,827 Kms
Good No.:	27157981	VIN:	MAJBXXMRKBGD27489
Next Service:	92420	Service History:	No
Note: This report is not a warranty

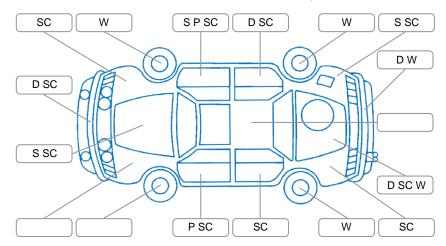
,				
S = Scratch	R = Rust	C = Crack	* = Decals	W = Significant scuffs
D = Dent	PT = Paint defect	P = Pin dent	SC = Stone Chips

Note: some defects and blemishes may not be displayed in the diagram $\,$

Stone chip front window screen
