Report ID:	27,158,394	Version:	1
Created:	31 Oct 2025

Make:	Honda	Model:	Shuttle
Body Style:	Wagon	Year:	2017
Rego No.:	PUN553	Rego Expiry:	18 Sep 2025
WoF Expiry:	01 May 2026	Odometer:	141,734 Kms
Good No.:	27158394	VIN:	7AT08G1XX23200606
Next Service:	no sticker	Service History:	No

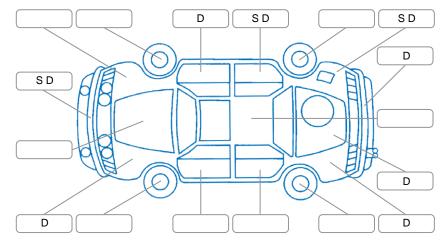
Note: some defects and blemishes may not be displayed in the diagram

Flat battery, windscreen cracked, rear view mirror faded, R side windscreen plastic cover missing,
