Basic Condition Guide

Make:	Honda	Model:	Odyssey
Body Style:	Wagon	Year:	2005
Rego No.:	MZN547	Rego Expiry:	05 Nov 2025
WoF Expiry:	06 Aug 2026	Odometer:	138,470 Kms
Good No.:	27163393	VIN:	7AT08G61X18117305
Next Service:	140,559km	Service History:	No

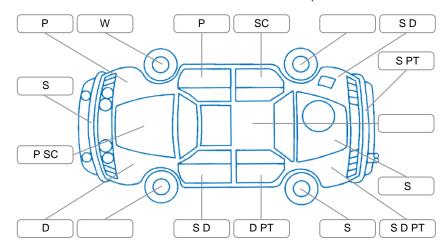
Note: some defects and blemishes may not be displayed in the diagram

R Pillar B dented and gouged. LF seat base pad torn. RF seat base pad worn. Centre seat base pad torn. R tail light cracked. LR door seal torn. Rear seats missing. Hoodlining stains. L sill scratches.
