Report ID:	27,168,672	Version:	2
Created:	07 Nov 2025

Make:	Nissan	Model:	Elgrand
Body Style:	SUV	Year:	2000
Rego No.:	GCJ482	Rego Expiry:	13 Apr 2026
WoF Expiry:	04 Nov 2025	Odometer:	144,153 Kms
Good No.:	27168672	VIN:	7AT0DH6MX11005137
Next Service:	140,000kms	Service History:	No

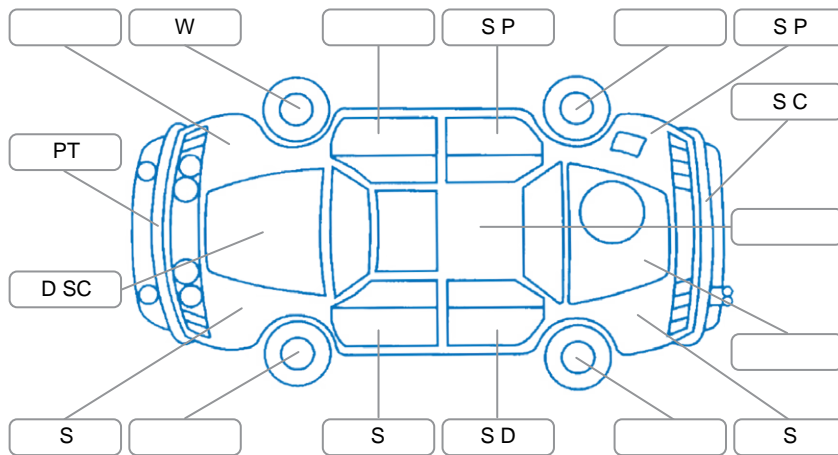
Paint cracked and flaking on front bumper. Right front guard inner liner is damaged. Left fog light is cracked. No tool kit. Needs Emergency silt release switch to shift from P to Drive. ( Brake pedal sensor is faulty)
