# **Basic Condition Guide**

Report ID:	27,172,570	Version:	1
Created:	11 Nov 2025

Make:	Subaru	Model:	Exiga
Body Style:	Wagon	Year:	2008
Rego No.:	QWU927	Rego Expiry:	25 Dec 2025
WoF Expiry:	18 Nov 2026	Odometer:	170,442 Kms
Good No.:	27172570	VIN:	7AT0GF1RX18003974
Next Service:	overdue 169557	Service History:	No

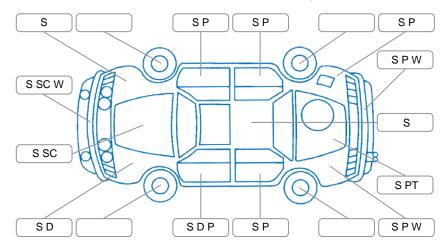
,				
S = Scratch	R = Rust	C = Crack	* = Decals	W = Significant scuffs
D = Dent	PT = Paint defect	P = Pin dent	SC = Stone Chips

Note: some defects and blemishes may not be displayed in the diagram

Rear view mirror delaminating. Door lock button on drivers door not working. Paint on drivers seatbelt. Oil low. Headlights yellowing. Rear bumper misaligned. Wingmirrors paint peel.
